## Strengthening and Repairing of Reinforced Concrete Beams by Ferrocement

**Abstract:** This paper presents a proposed method for strengthening and repairing of reinforced concrete beams using ferrocement laminates as a viable alternative to steel plates and carbon fibers sheets which are directly glued to the cracked tension face of the beam by epoxy resins without shear connectors. The results of the experimental investigation to examine the effectiveness of this method are reported and discussed including strength, deflection, compressive and tensile strains, ductility ratio, Energy absorption properties and cracking characteristics of the strengthening and repairing of the reinforced concrete beams. Fifteen reinforced concrete beams were tested under four lines loadings until failure over simply supported 900mm span and having the dimensions of 50x100mm in cross section. The experimental program comprises three designations series. Series I include beam 1 control and beam 9 controls which conventional reinforced with steel bars and stirrups without and with polypropylene fibers respectively. Series II consists of beams 2-8 which were repaired after failure with various types

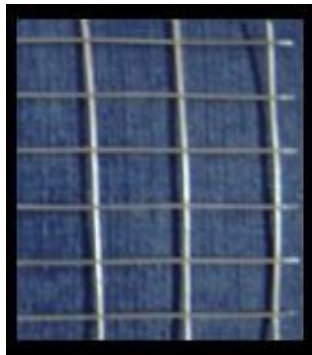
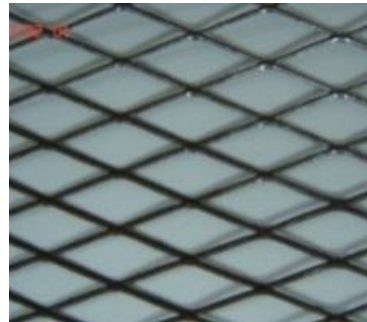
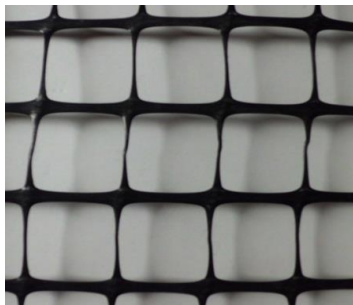
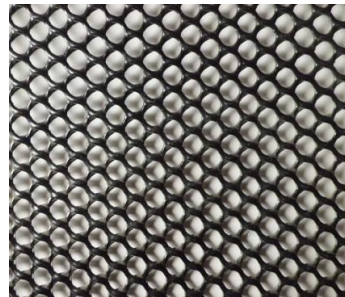
Figure 5: Types of materials used.

a) Welded wire mesh

b) Expanded wire mesh

c) Tenser mesh

d) Polyethylene mesh

Two types of steel meshes were used to reinforce the ferrocement beams. These types are expanded steel mesh and WSM welded steel mesh, Figure 5. The details of the geometric properties of these two types are given in Table 2.

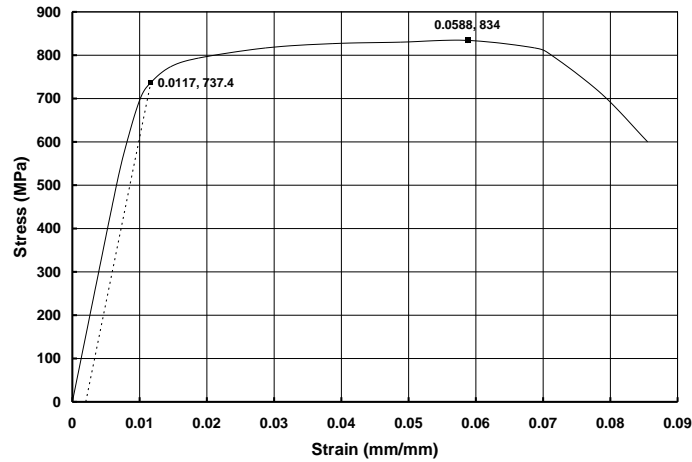
Figure 6: Stress-strain relationship for the welded wire mesh

Table 2: Mechanical properties of steel meshes\

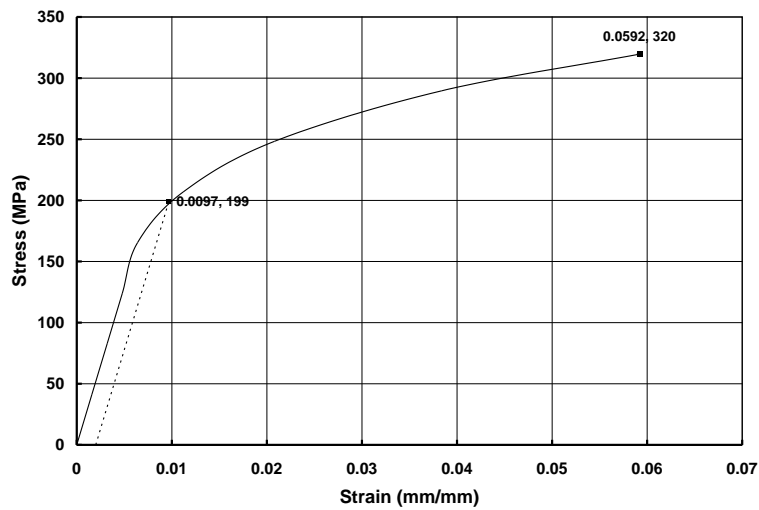
Figure 7: Stress-strain relationship for the expanded steel mesh

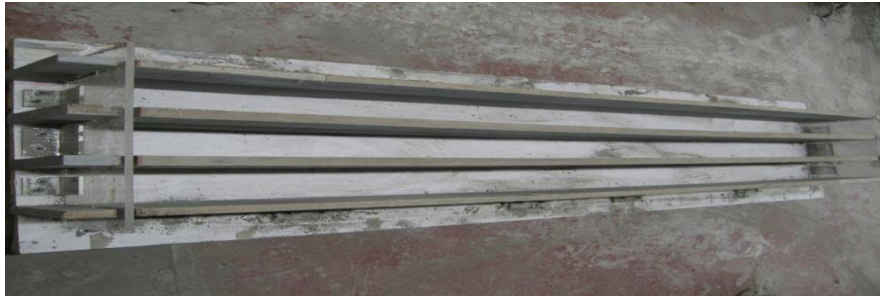
**Fig. 8 Wooden mold for casting beams.**

A wooden mold has been utilized to cast ferrocement rectangular sections shaped forms. The wooden mold consists of three events to produce three beams having the dimensions of 50mm with, 100 height and 1000mm long at the same time as shown in Figure 8.

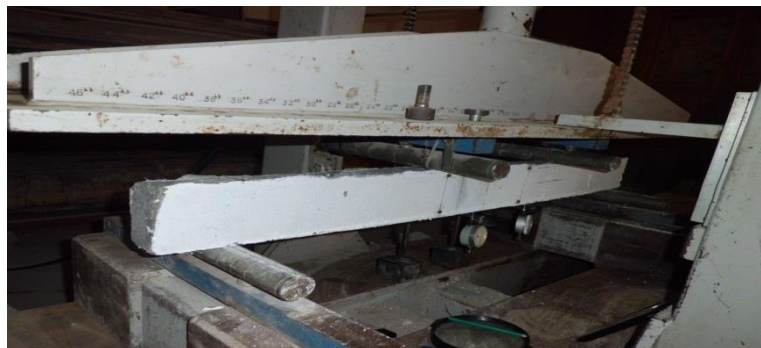
**Fig. 9 Test set up**

After 28 days, the specimens were painted with white paint for better crack detection and marking during the testing process. A set of three dial gauges were placed under the test specimen to measure the deflections at three locations. All test specimens were tested on the universal testing machine. The test was conducted under four line loadings as shown in Figure 9. The specimen was centered on the testing machine, where the span between the two supports was kept at 1400mm. A dial gauge was placed under the center of the specimen to measure the deflection versus load. The load was applied at 5 KN increments, by a hydraulic jack, on. Cracks were traced and marked throughout the side of the specimen. The first crack-load of each specimen, crack propagation, and failure mode was recorded. The load was increased until the failure of the specimen.

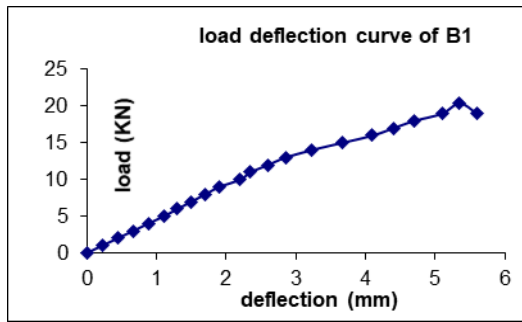
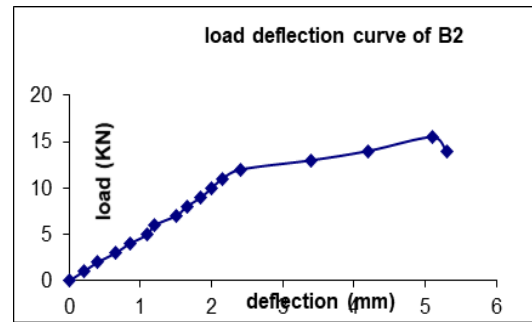
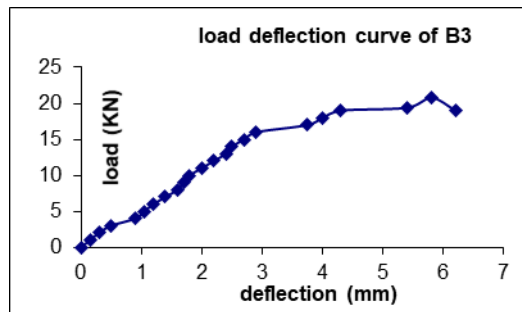
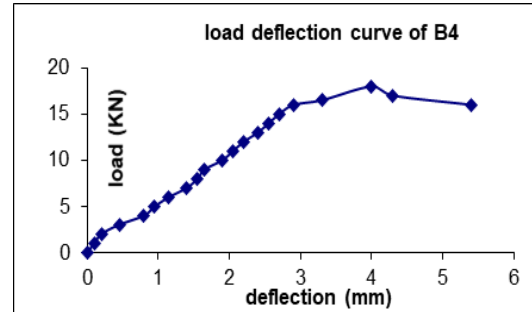
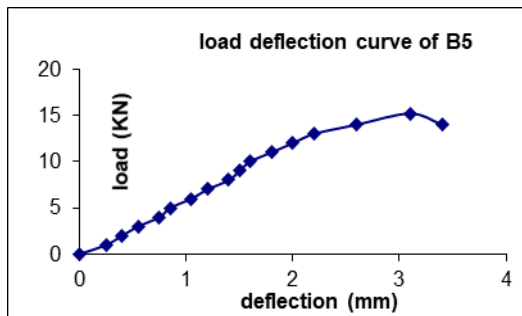
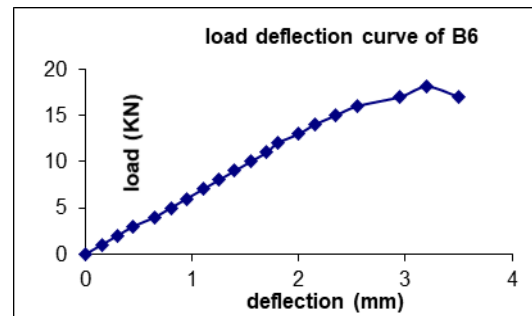
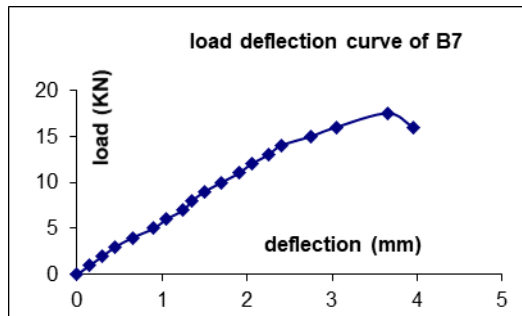
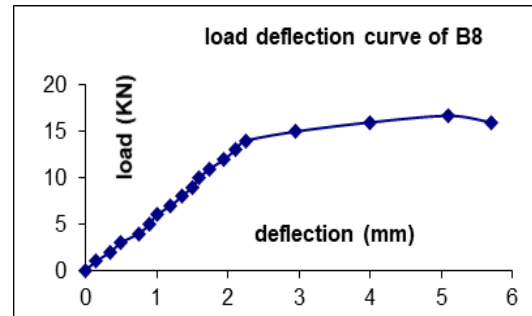
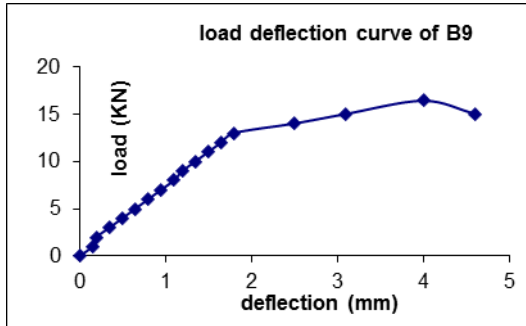
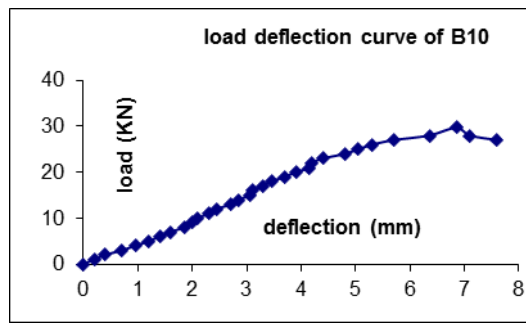
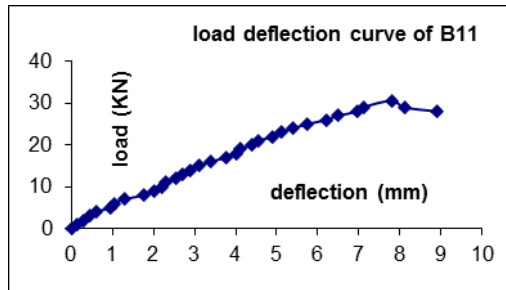
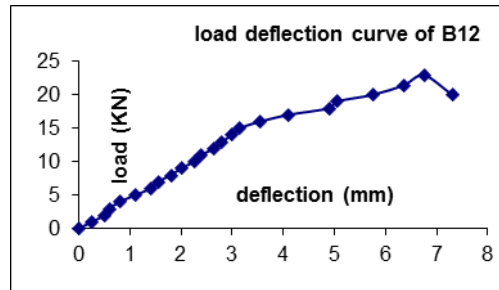
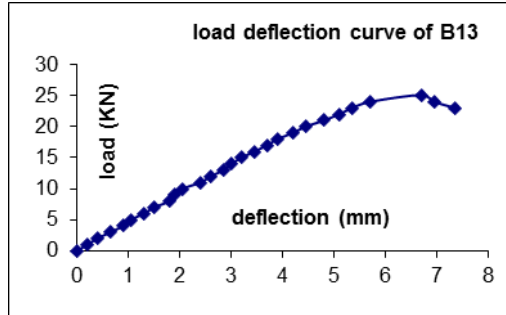
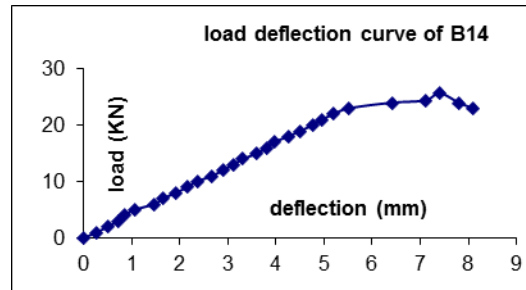
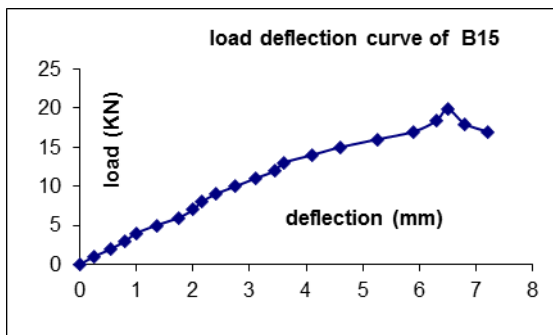
**Fig. 10** Load deflection curves of beam B1

**Fig. 11** Load deflection curves of beam B2

**Fig. 12** Load deflection curves of beam B3

**Fig. 13** Load deflection curves of beam B4

**Fig. 14** Load deflection curves of beam B5

**Fig. 15** Load deflection curves of beam B6

**Fig. 16** Load deflection curves of beam B7

**Fig. 17** Load deflection curves of beam B8

Fig. 18 Load deflection curves of beam B9

Fig. 19 Load deflection curves of beam B10

Fig. 20 Load deflection curves of beam B11

Fig. 21 Load deflection curves of beam B12

Fig. 22 Load deflection curves of beam B13

Fig. 23 Load deflection curves of beam B14

Fig. 24 Load deflection curves of beam B15

The plotted central deflections of the test specimens against the applied load are shown in Figures 10-24 and Figs. 25-31. It can be seen from these Figures that the load-deflection relationship of the test specimens can be divided into three stages as follows:

- a) Elastic behavior until the first cracking. The load-deflection relationship in this stage is linear. The slope of the load-deflection curve in this stage varies with different types of the test specimens. The end of this stage is marked by the deviation from linearity. The extent of this stage vary with the type and number of layers of the steel meshes.

- b) In the second stage, the slope of the load-deflection curve changes gradually due to the expected reduction in the specimens' stiffness as the result of multiple cracking. The gradient of the load-deflection curve increases with the increase of the volume fraction of the reinforcement.

- c) In the third stage, large plastic deformation occurred as the result of yielding of the reinforcing bars and the steel meshes in the ferrocement beams. The load-deflection relationship for the control specimens was linear up to a first crack load after which the relation became nonlinear.

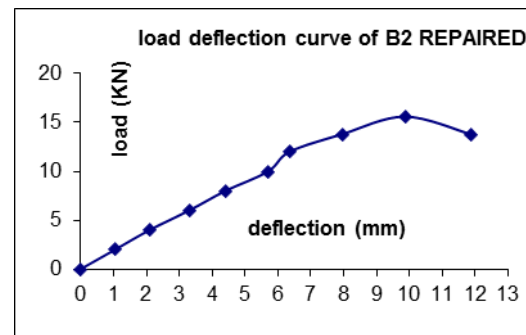
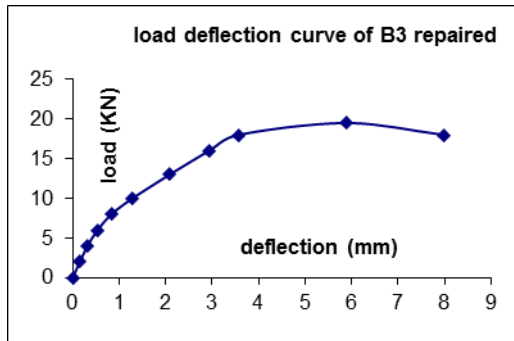
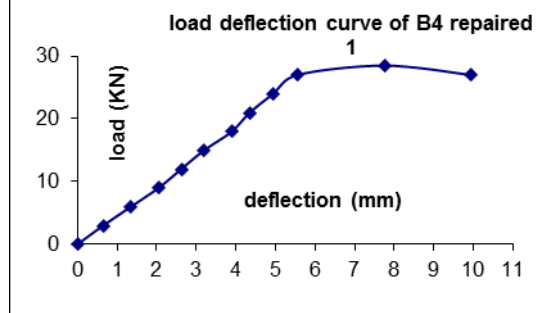
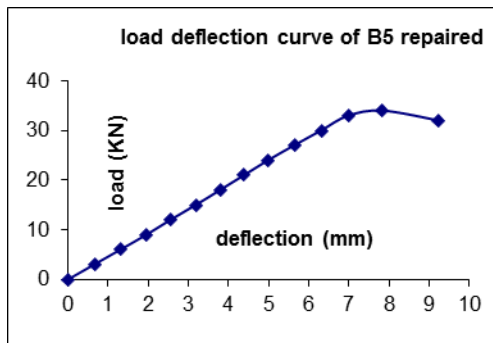
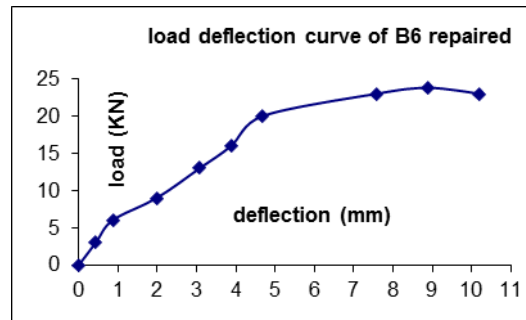
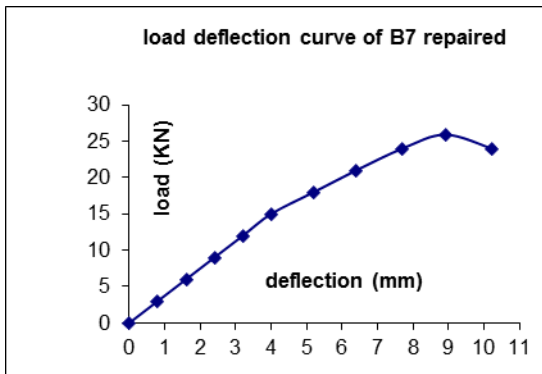
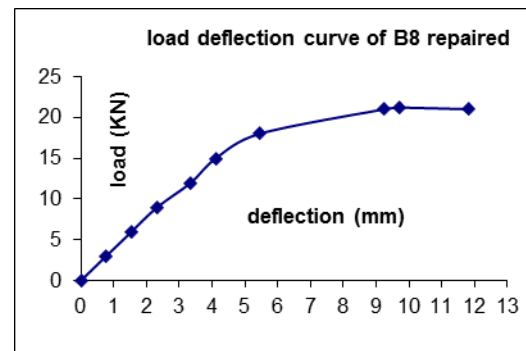
Fig. 25 Load deflection curves of beam B2 repaired

**Fig. 26** Load deflection curves of beam B3 repaired

**Fig. 27** Load deflection curves of beam B4 repaired

**Fig. 28** Load deflection curves of beam B5 repaired

**Fig. 29** Load deflection curves of beam B6 repaired

**Fig. 30** Load deflection curves of beam B7 repaired

**Fig. 31** Load deflection curves of beam B8 repaired

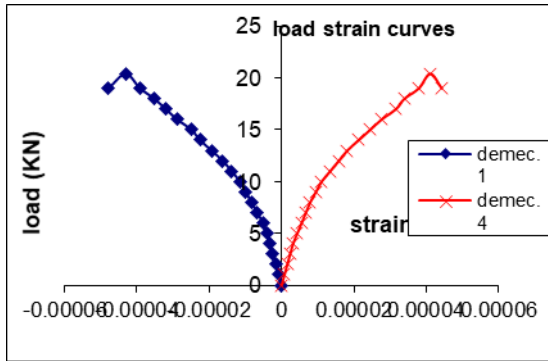
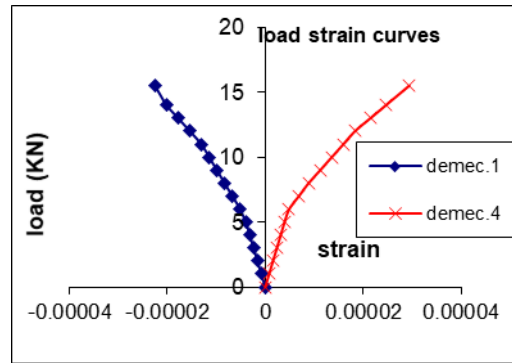
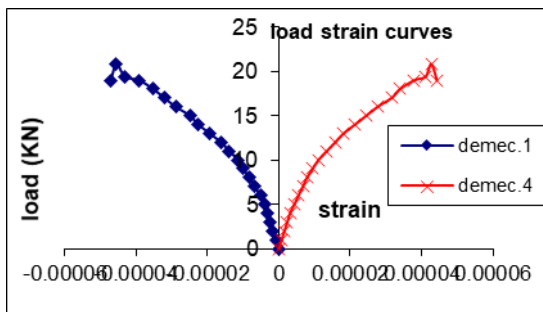
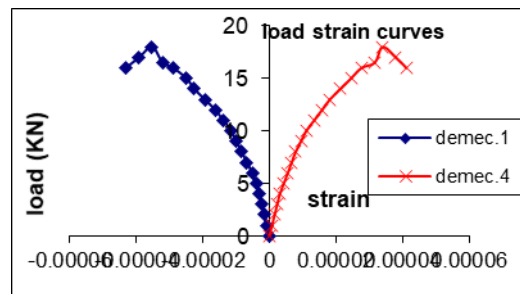
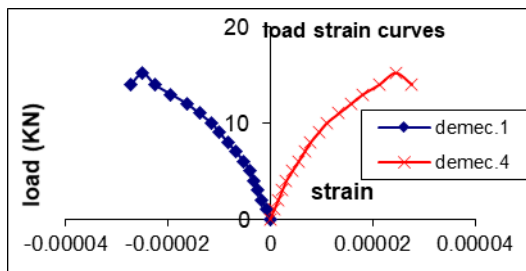
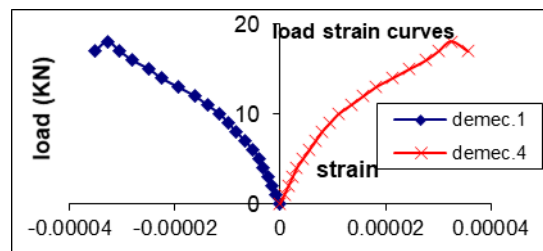
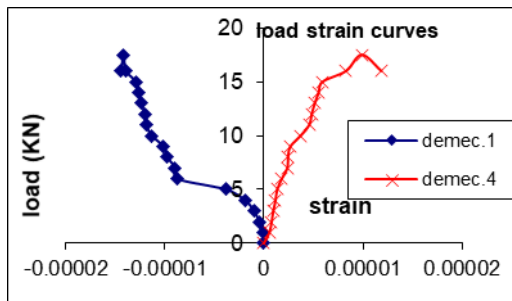
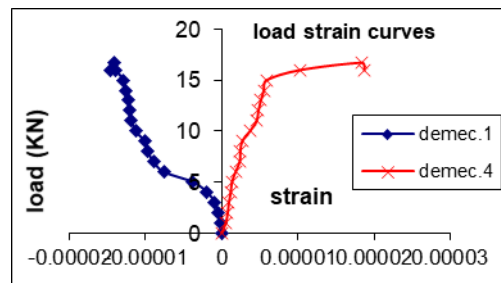
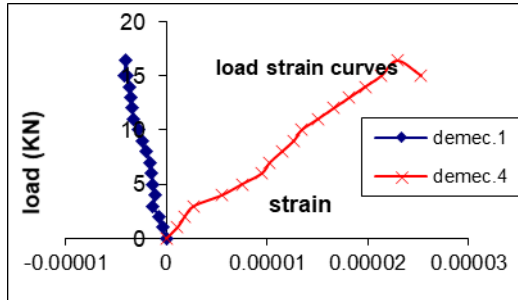
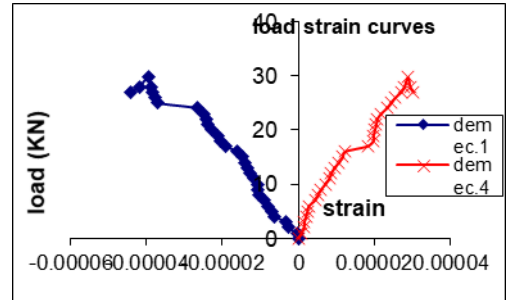
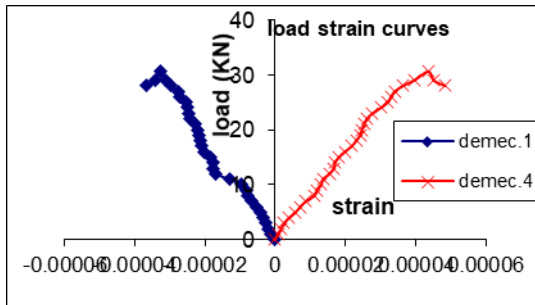
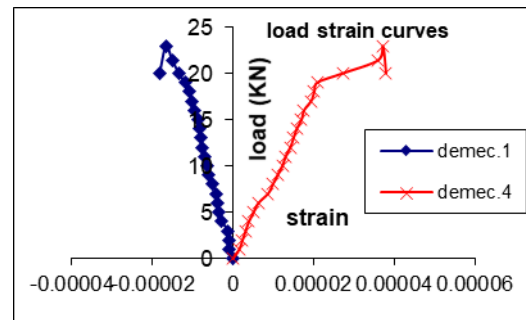
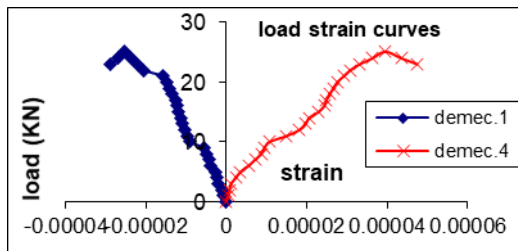
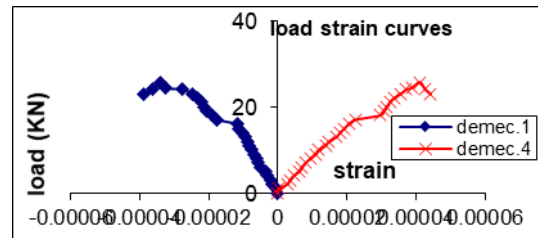
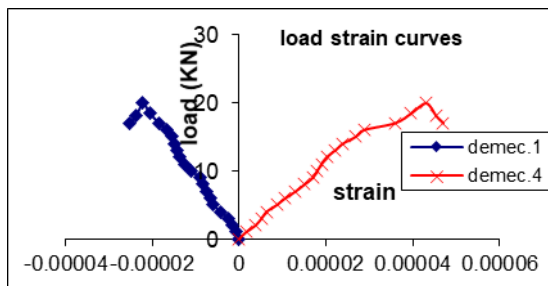
**Fig. 32 Load strain curves of beam B1.**

**Fig. 33 Load strain curves of beam B2.**

**Fig. 34 Load strain curves of beam B3**

**Fig. 35 Load strain curves of beam B4**

**Fig. 36 Load strain curves of beam B5**

**Fig. 37 Load strain curves of beam B6**

**Fig. 38 Load strain curves of beam B7**

**Fig. 39 Load strain curves of beam B8**

**Fig. 40 Load strain curves of beam B9**

**Fig. 41 Load strain curves of beam B10**

**Fig. 42 Load strain curves of beam B11**

**Fig. 43 Load strain curves of beam B12**

**Fig. 44 Load strain curves of beam B13**

**Fig. 45 Load strain curves of beam B14**

**Fig. 46 Load strain curves of beam B15**

Figs. 32- 46 show load tensile and compressive strains curves of all the tested beams respectively. Table 3 presented maximum tensile and compressive strains of all the tested beams. Figs. 47-54 show load tensile and compressive strains curves of all repaired beams B2-B8 respectively.

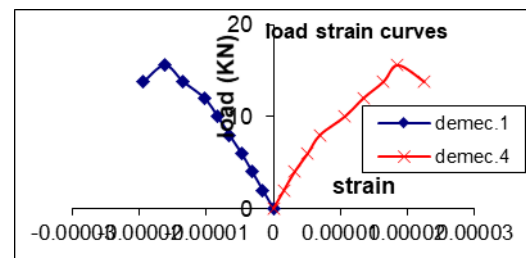
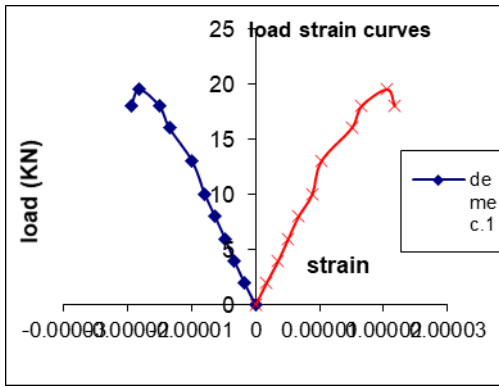
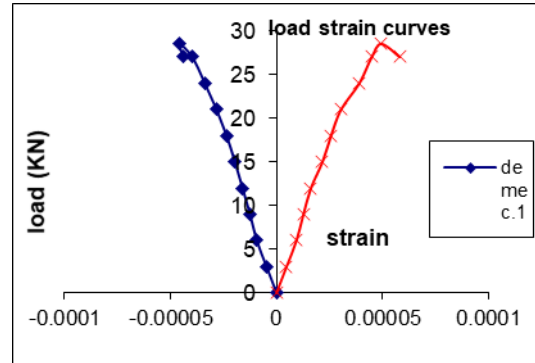
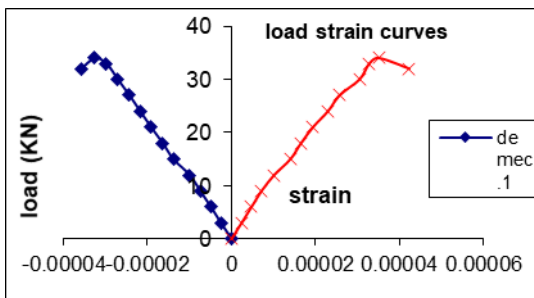
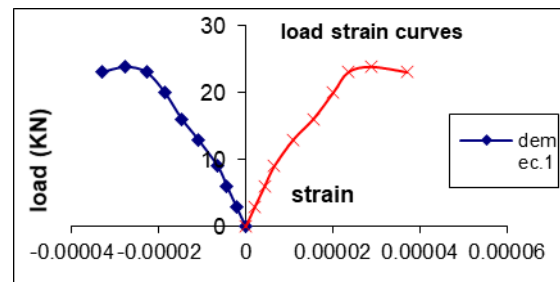
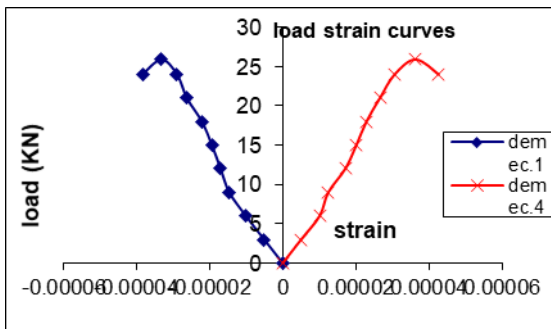
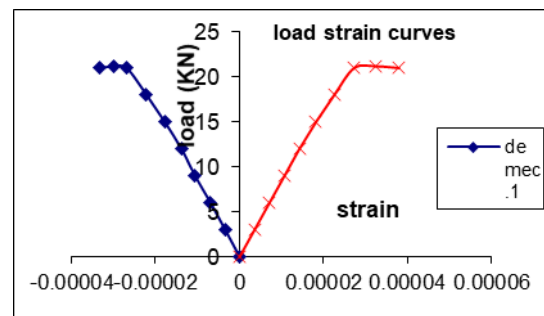
**Fig. 47 Load strain curves of beam B2 repaired**

**Fig. 48 Load strain curves of beam B3 repaired**

**Fig.49 Load strain curves of beam B4 repaired**

**Fig.50 Load strain curves of beam B5 repaired**

**Fig.51 Load strain curves of beam B6 repaired**

**Fig.52 Load strain curves of beam B7 repaired**

**Fig.53 Load strain curves of beam B8 repaired**

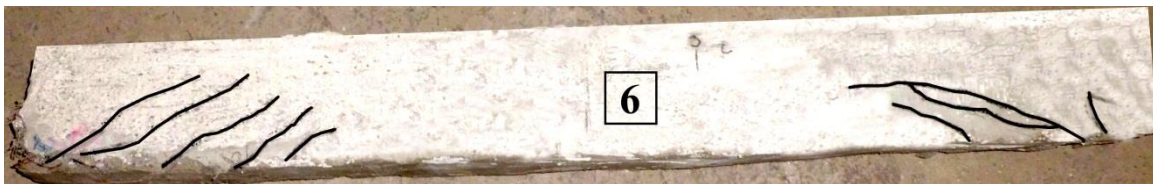
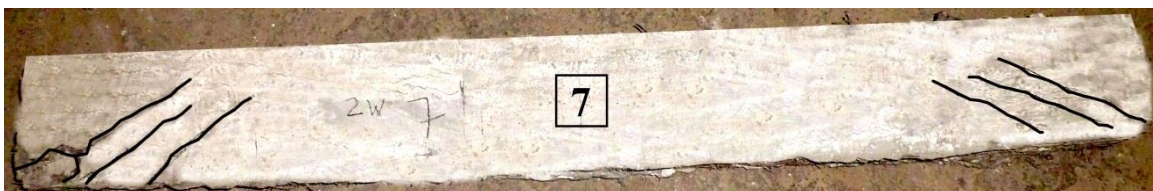
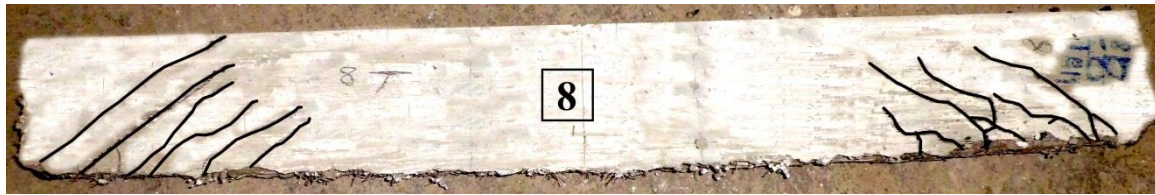
**Fig. 73 Cracking pattern of beam 6 Repaired.**

**Fig. 74 Cracking pattern of beam 7 Repaired.**

**Fig. 75 Cracking pattern of beam 8 Repaired.**

Figures 55-68 show the cracking patterns for test B2-B15 respectively. While Figures 69- 75 show cracking patterns of repaired beams B2- B8 respectively. It is interesting to note that specimens of the group repaired with various layers of Welded steel mesh exercise better-cracking patterns. The first crack for this group occurred nearly at mid-span. As the load increased, it was noticed that new cracks were developed at both sides of the first crack, while the first crack propagated vertically. With the additional increase of the load, new parallel cracks were developed while the previously developed cracks propagated nearly vertically. This pattern of cracks development continued till failure of beams. There is no spalling of concrete cover this is predominant.

The crack patterns of test specimens of the group repaired with various layers of expanded steel mesh were similar to those of the previous group reinforced with welded layers of steel mesh. The first crack occurred nearly at mid-span. As the load increased, it was noticed that new parallel cracks were developed at both sides of the first crack, while the first crack propagated vertically. With the additional increase of the load new vertical cracks were developed, while the previously developed cracks propagated upwards. There are no signs of shear failure were observed for this group as shown in Figs. 69-75.

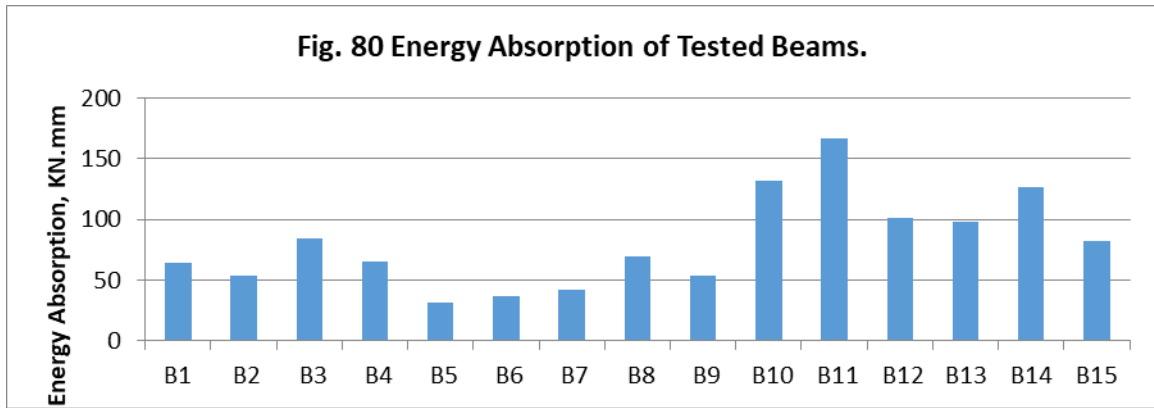
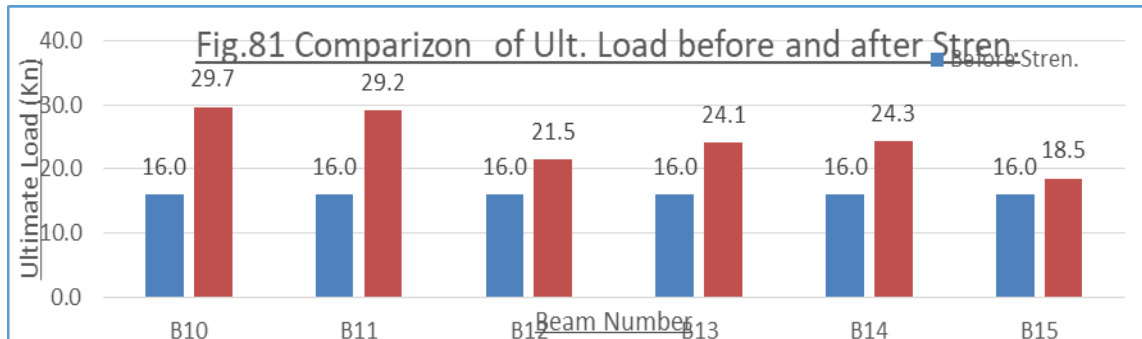
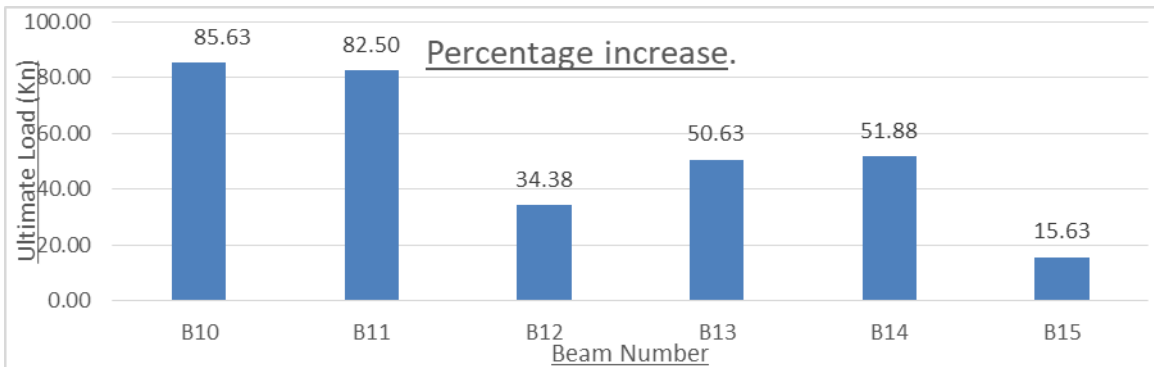
**Fig.82 Percentage increase in ultimate loads of Beams B10-b15**

Fig. 81 shows the comparison of ultimate loads of beams B10-B15 before and after strengthening of all the tested beams. It is interesting to note that beam B10 emphasizes the heights ultimate load reached 29.7 KN. Fig. 82 shows the comparison of percentage increase of ultimate load reached 85.63% that is great.

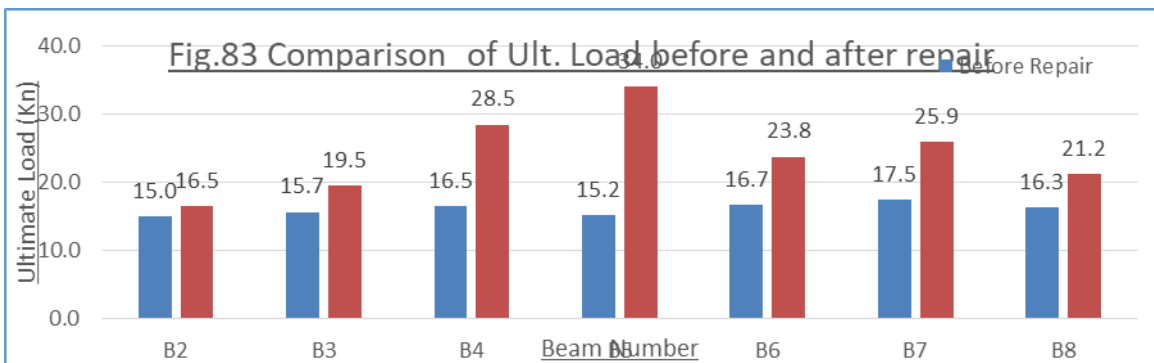
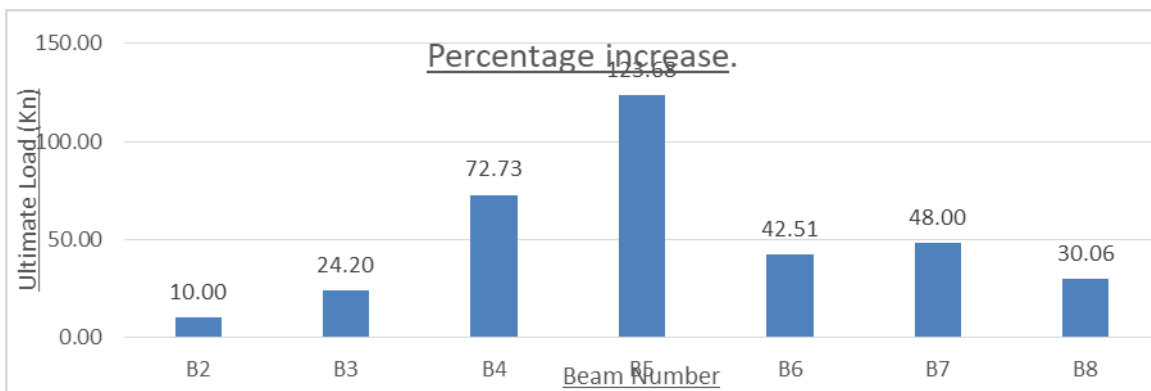
**Fig.84 Percentage increase in ultimate loads of Beams B2-B8.**

Fig. 83 shows the comparison of ultimate loads of beams B2-B8 before and after repairing of all the tested beams. It is interesting to note that beam B5 emphasizes the heights ultimate load reached 34 KN. Fig. 84 shows the comparison of percentage increase of ultimate load reached 123.68 % that is so great.
